Technical Report CERC-95-9
July 1995

Monitoring of the Yaquina Bay Entrance North Jetty at Newport, Oregon; Summary and Results

by Steven A. Hughes, Terri L. Prickett,
Michael W. Tubman, William D. Corson

Final report

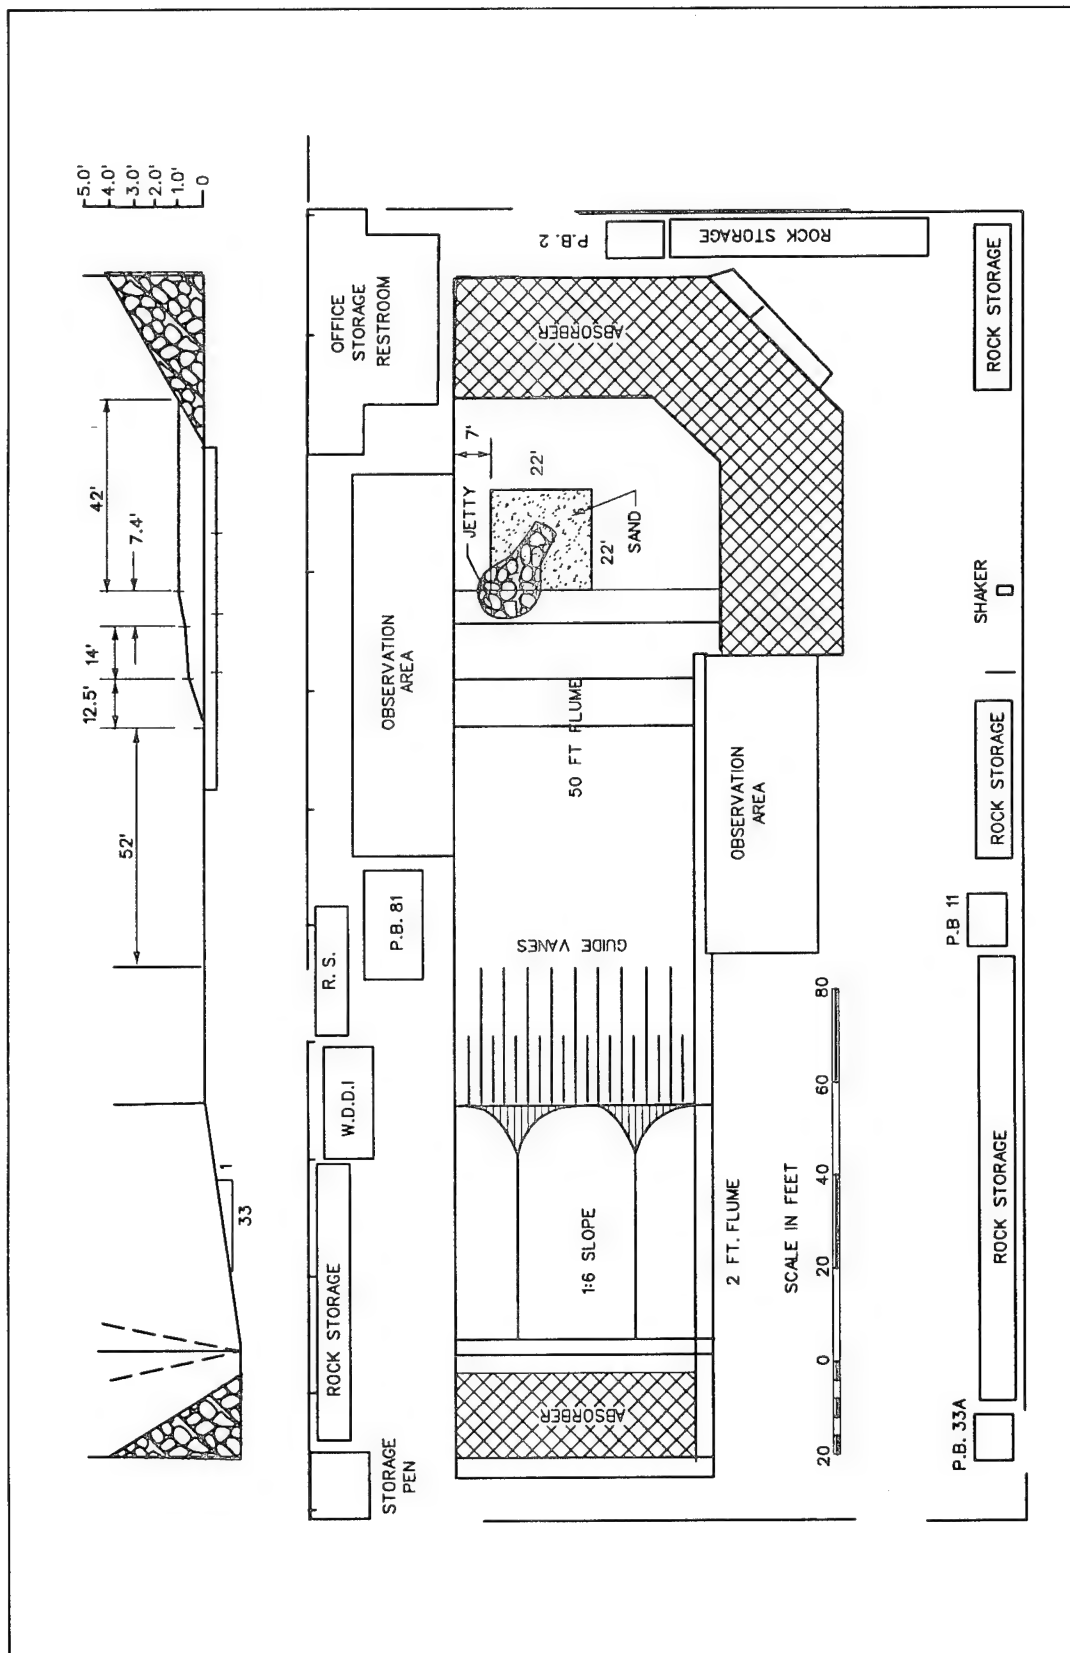
Figure 62. L-Shaped Flume plan view with movable-bed Yaquina Bay north jetty model

- b. The movable-bed portion of the model consisted of a sand pit located in the concrete floor of the model facility. The model jetty was constructed over a sand bed (median grain size diameter 0.13 mm) with the tip of the jetty resting on the concrete bottom, which simulated the hard reef bottom (see Figure 62). The straight edge of concrete next to the sand bed was used to represent the landward edge of the Yaquina Reef. (In the prototype this demarcation line is not straight.)

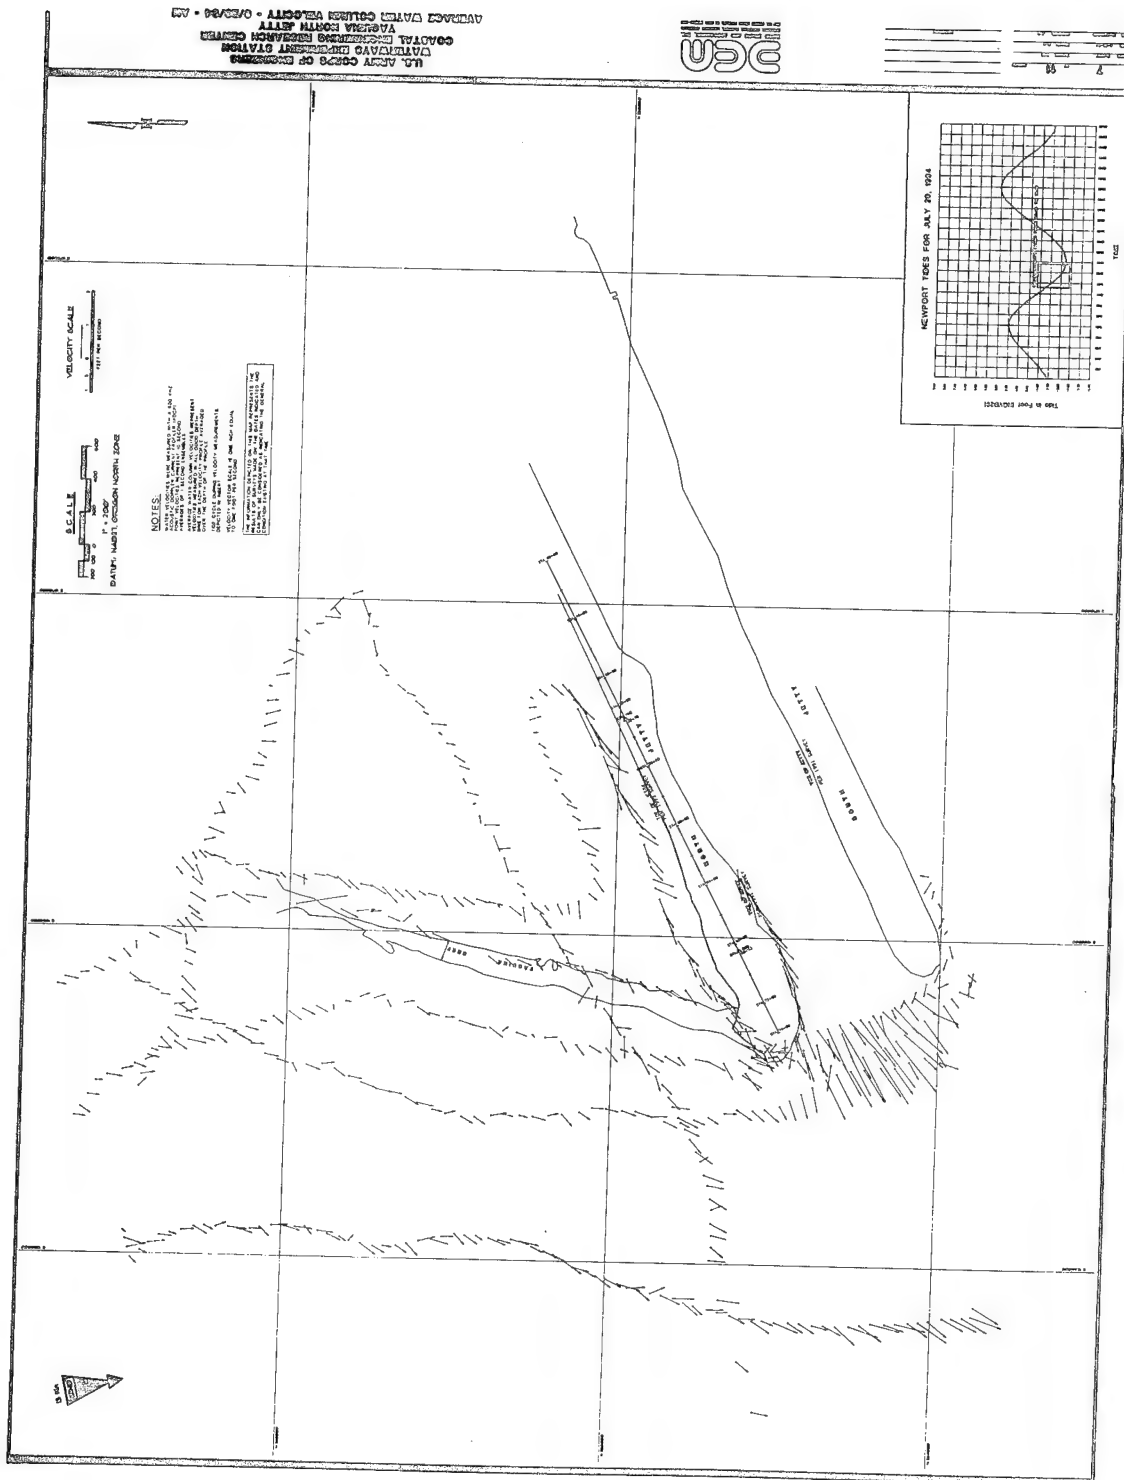
Figure 69. Depth-averaged current velocity vectors at Yaquina Bay north jetty (morning of 29 June 1994)

Depth-averaged velocity vectors for the morning ADCP deployment are drawn on Figure 69. Survey time relative to the tidal cycle is illustrated on

the lower corner of the figure. Longshore current velocities were relatively weak with average magnitudes around 10-20 cm/s (0.3-0.7 ft/s) during the survey period. However, even with this weak forcing, the role played by the north jetty in accelerating the longshore flow and redirecting it seaward is evident. Largest flow velocities on Figure 69 correspond to the ebb tidal flow at the navigation entrance.

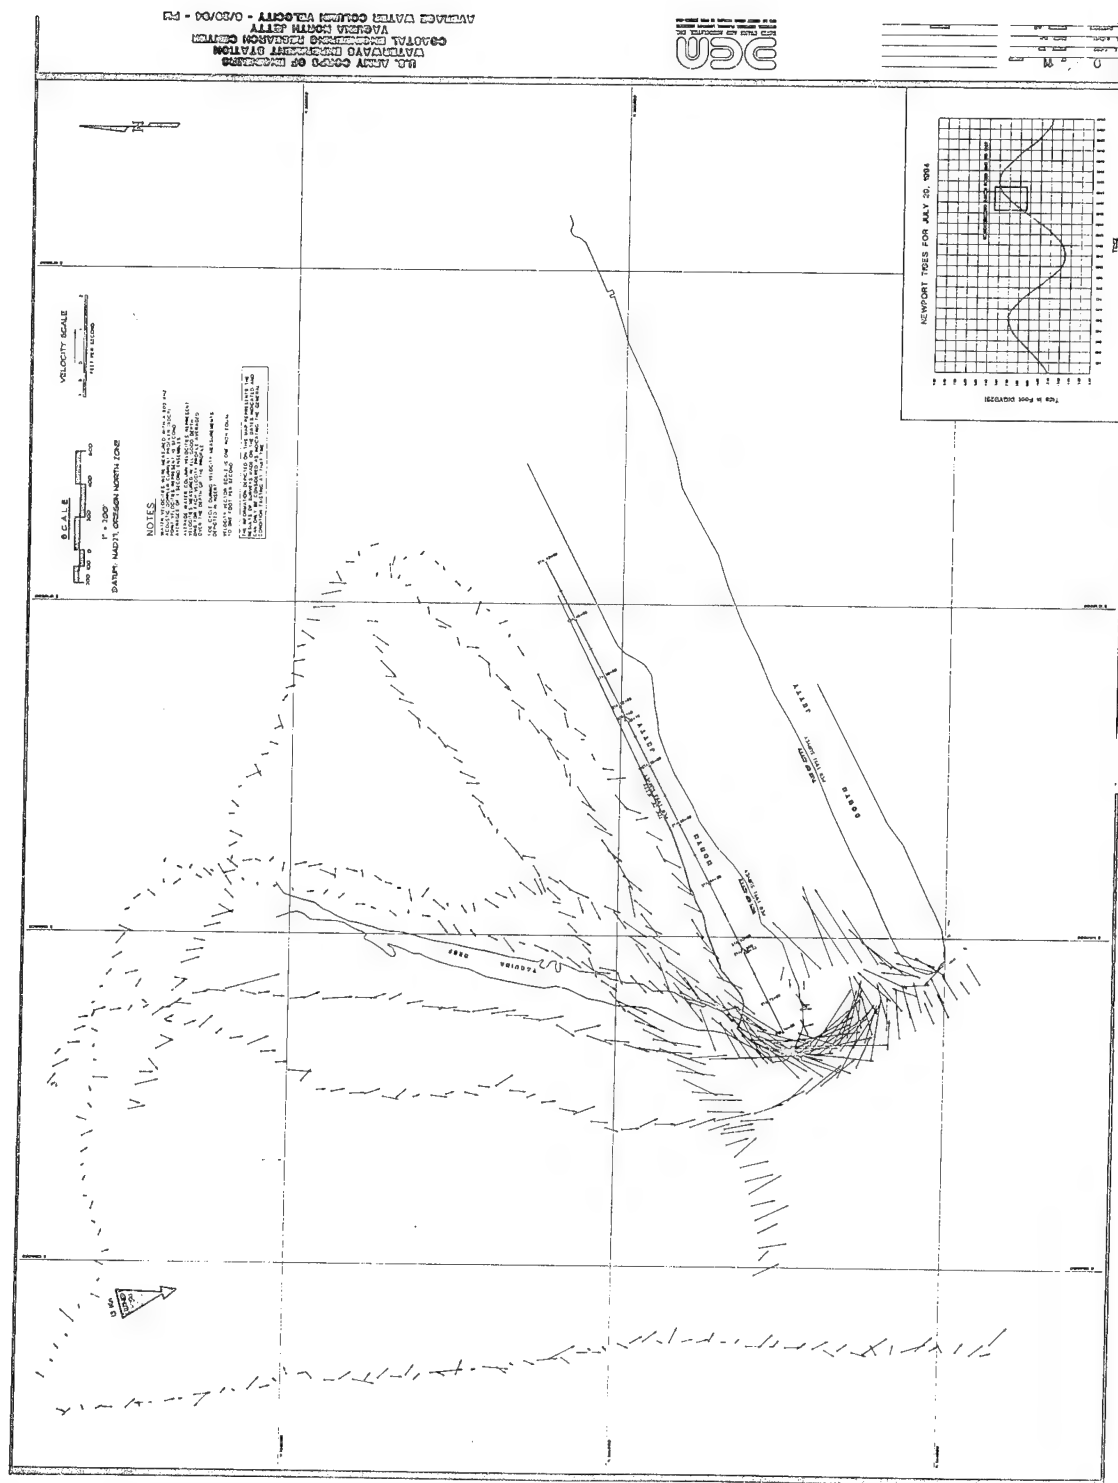
Figure 70. Depth-averaged current velocity vectors at Yaquina Bay north jetty (afternoon of 29 June 1994)

Fourth ADCP deployment (June 29, 1994). The fourth and final ADCP deployment began at 1512 PDT and lasted about 2 hr. Wind and wave conditions remained the same as experienced during the previous survey episode that morning, but the time-averaged water level over the survey was about 1.5 m (5 ft) higher. Current velocity vectors and the tide stage over the survey duration are shown on Figure 70.

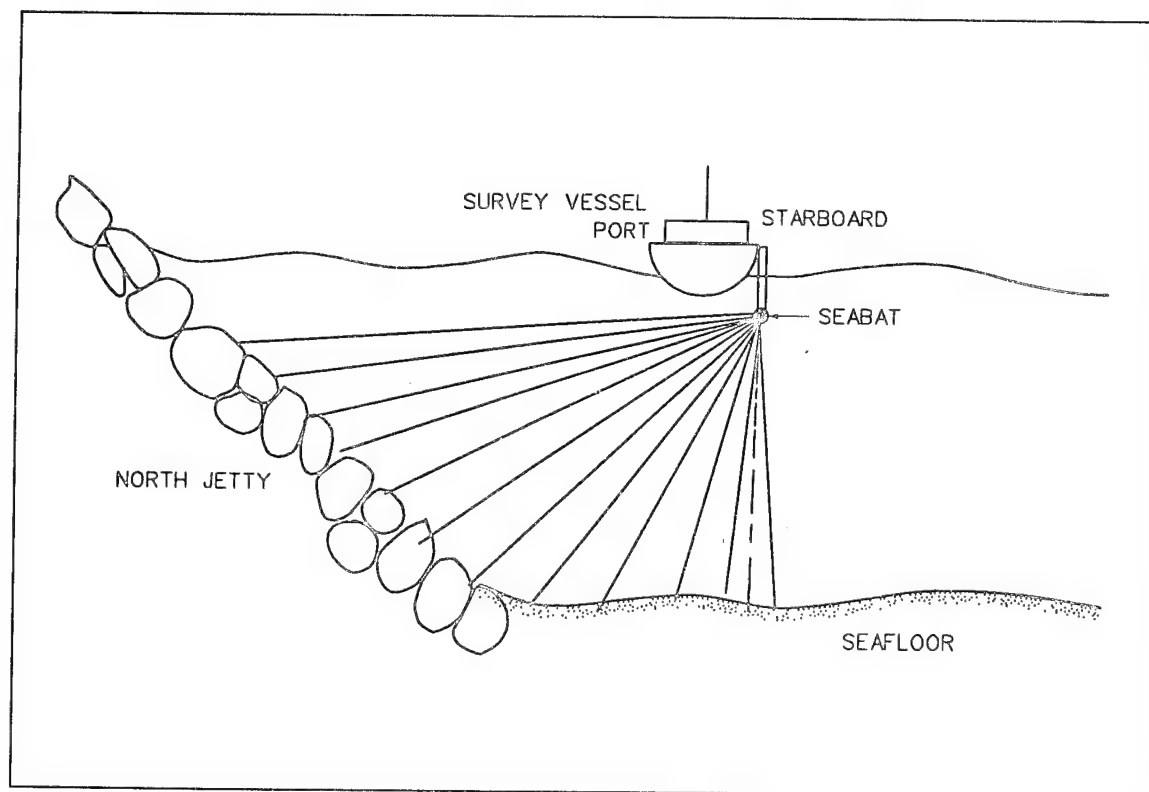
Figure 71. SEABAT mounting and swath coverage

Usually, the SEABAT is deployed in a downward-looking orientation with the center beam directly beneath the transducer and bottom coverage 45 deg to each side of the vertical. For the survey of the underwater portion of the north jetty, the SEABAT was oriented with the center beam 40 deg to the port side of the vertical, and the swath plane was perpendicular to the vessel center line (i.e., parallel to the ship's beam). The transducer head was mounted off the starboard side of the vessel and positioned at a depth of 0.7 m (2.3 ft) below the survey vessel's waterline, which allowed all beams in the swath to pass beneath the vessel's keel. This mounting position and orientation were chosen so the survey of the north side of the north jetty could be conducted while heading offshore into the incident waves (safest direction). Swath coverage was approximately between 5 deg to starboard of the vertical and 5 deg from the water surface to port. The 5-deg orientation below the water surface helped to reduce the amount of error induced by sea surface sonic reflections due to either wave fluctuations or vessel roll, and it also helped to decrease errors caused by aeration in the upper water column near the jetty. SEABAT mounting and swath coverage are illustrated in Figure 71.

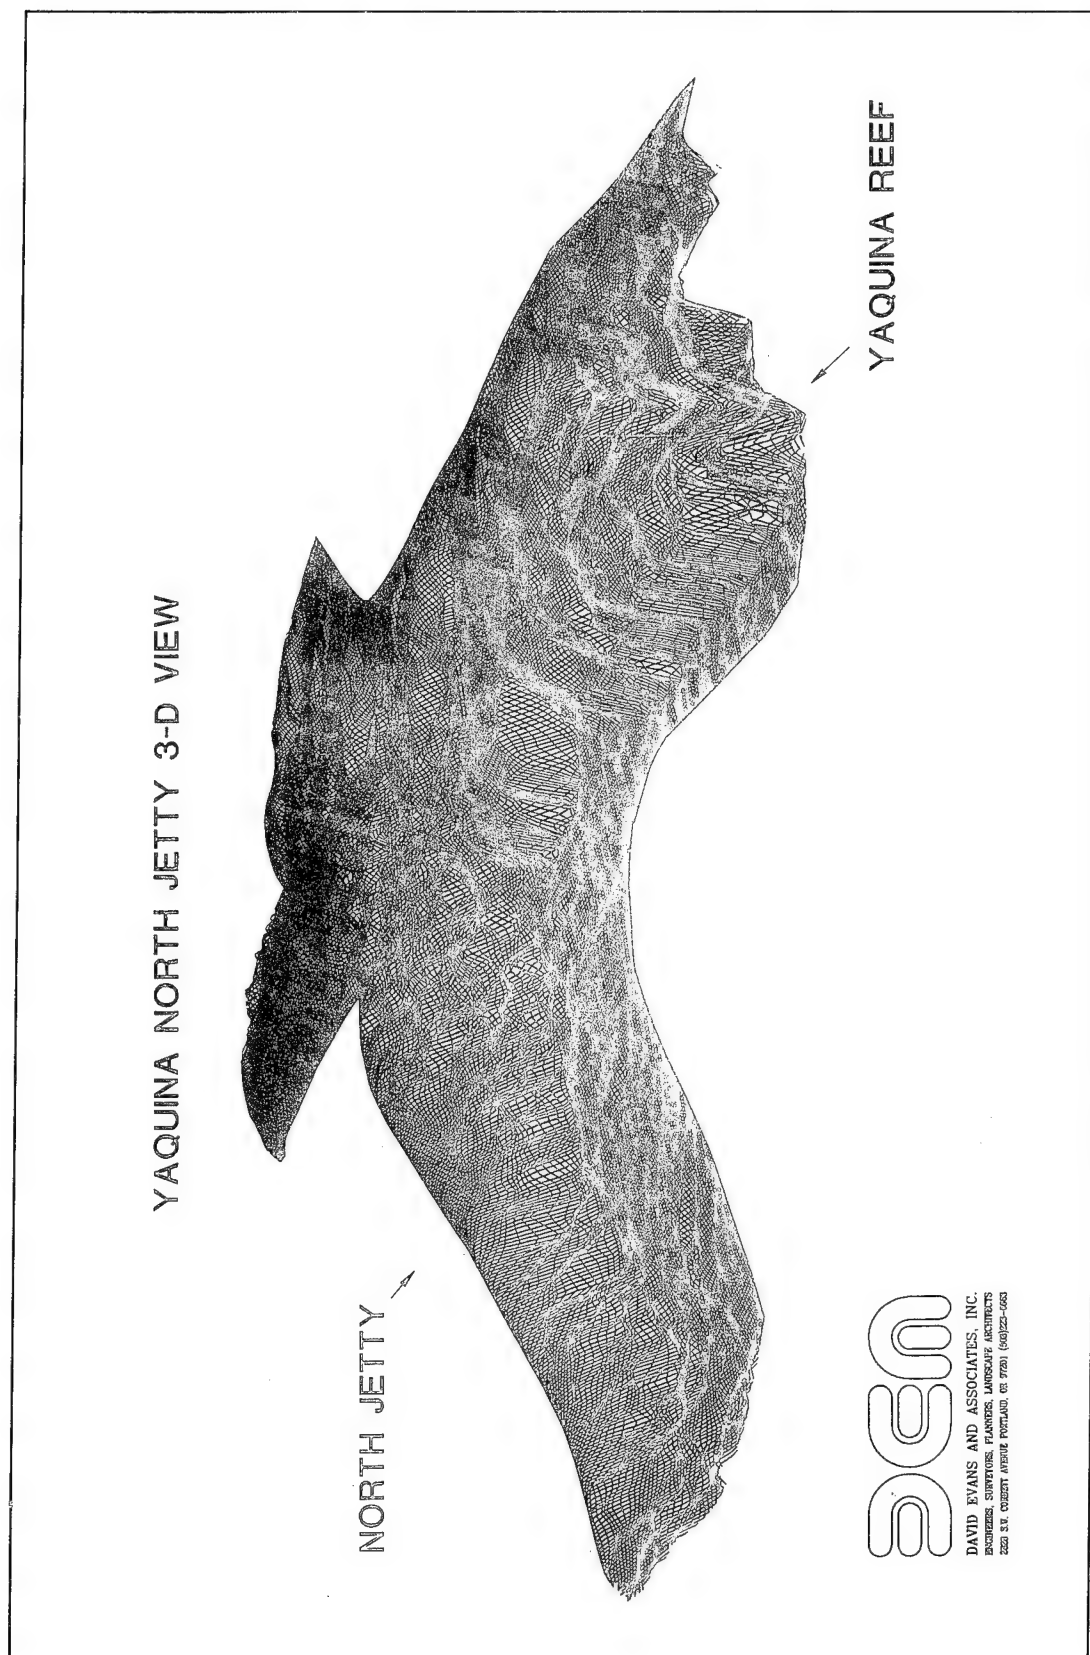
Figure 72. Orthographic "mesh" of Yaquina Bay north jetty and Yaquina Reef below-water bathymetry

Corrected elevation and position data from all the SEABAT tracklines were used in a digital terrain model to create a three-dimensional "mesh" of the seafloor, Yaquina Reef, and underwater portion of the north jetty covered by the survey. Figure 72 presents a view of this mesh from a perspective landward of Yaquina Reef and to the northeast of the north jetty tip. The north jetty is shown extending seaward from the left of the figure and intersecting with the reef. The smooth line to the top of the jetty mesh portion represents the uppermost limit of SEABAT data.

Note in particular on Figure 72 that the north jetty underwater slope becomes very mild toward the location where the jetty intersects with Yaquina Reef. This mild slope is assumed to consist of relic armor stone left from the last two rehabilitations. Also notice the very steep face on the landward side of Yaquina Reef. This reef formation could have significance in helping to direct longshore flowing currents seaward along the jetty.

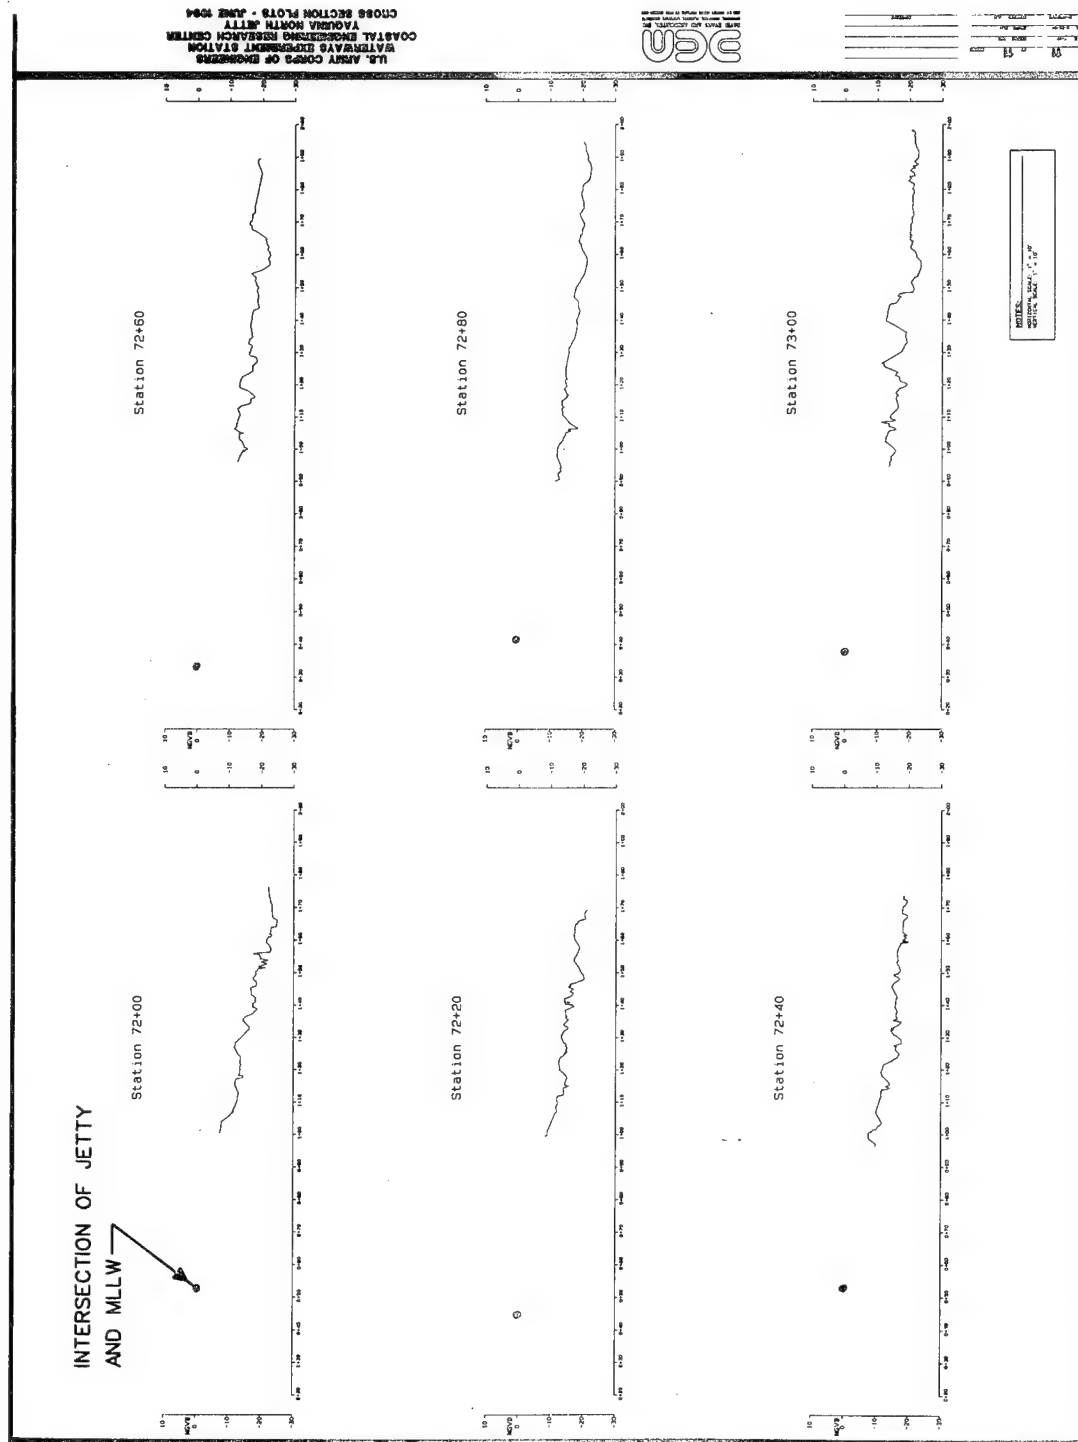
Figure 73. Underwater SEABAT profiles of the north side of the Yaquina Bay north jetty

The SEABAT elevation data were referenced to the same coordinate system used to display the photogrammetric elevation results for the above-water portion of the jetty. This allowed construction of cross-section profiles from the 0.3-x 0.3-m (1-ft x 1-ft) mesh grid that corresponded to selected jetty stations. Underwater profile cross sections for north jetty stations 72+00 through 73+00 are shown on Figure 73. The profiles are drawn at a scale that is only slightly distorted. The black dot drawn on each profile represents the approximate position of the north jetty profile at the mllw datum. The gap

between the dot and the profile is the region of the jetty that could not be surveyed by either photogrammetric methods or by SEABAT.
